Contract #: 04-0120F4Cty: SF/ALA Rte: 80 PM: 13.2/13.9File #: 69.28**WELDING INSPECTION REPORT****Resident Engineer:**Pursell, Gary**Address:** 333 Burma Road**City:** Oakland, CA 94607**Report No:** WIR-000752**Date Inspected:** 02-Nov-2007**Project Name:** SAS Superstructure**OSM Arrival Time:** 600**Prime Contractor:** American Bridge/Fluor Enterprises, a JV**OSM Departure Time:** 1530**Contractor:** Zhenhua Port Machinery Company, Ltd (ZPMC), Changxing Island **Location:** Shanghai,China**CWI Name:** Zhu Zhong hai**CWI Present:** Yes No**Inspected CWI report:** Yes No N/A**Rod Oven in Use:** Yes No N/A**Electrode to specification:** Yes No N/A**Weld Procedures Followed:** Yes No N/A**Qualified Welders:** Yes No N/A**Verified Joint Fit-up:** Yes No N/A**Approved Drawings:** Yes No N/A**Approved WPS:** Yes No N/A**Delayed / Cancelled:** Yes No N/A**Bridge No:** 34-0006**Component:** Skin Plate**Summary of Items Observed:**

WELDING INSPECTION REPORT

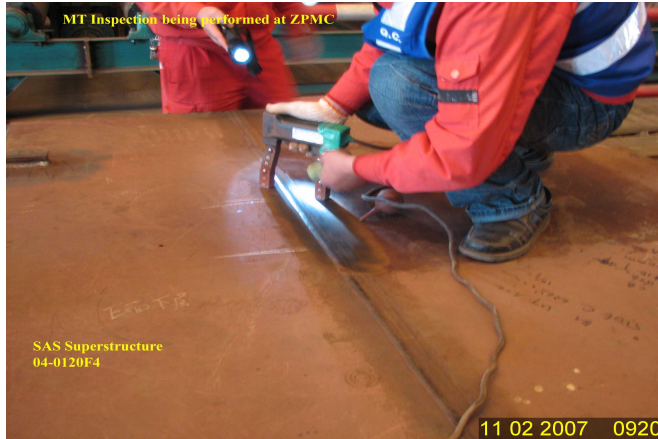
Item	Description	WBS	Dwg No.	Status
1	89M skin plate E			in progress
	Caltrans QA Inspector observed the Magnetic Particle (MT) Inspection on skin plate E splice weld of the upper and lower portion of the skin plate. ZPMC Cai Xin xin performed the inspection of the final weld pass on piece numbers: musc to MA108, weld numbers W5 and W6. MT was performed with an Alternating Current (AC) yoke; model B310S and a serial number 4984. What appeared to be a 10 lbs test block was used to verify lifting strength and a Pie gage was used to verify field direction. Dry Powder method was used to perform the inspection, using gray contrasting power. It appeared MT Inspection was being performed correctly and no indications were found

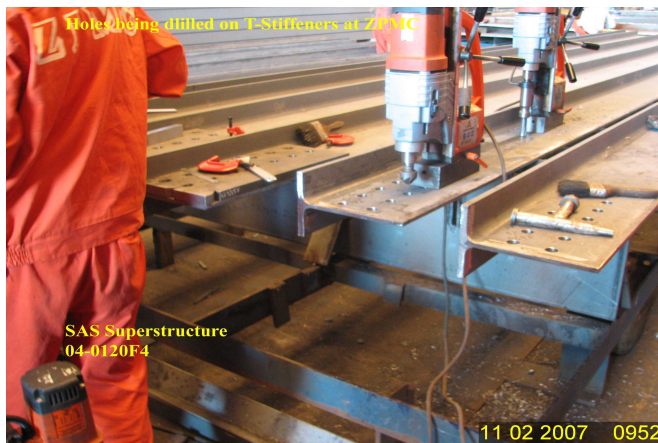
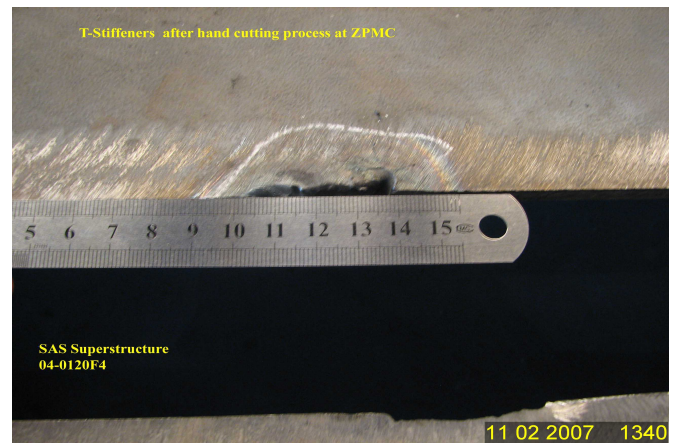
2 OBG

Caltrans QA Inspector observed drilling of holes in WT Stiffeners for OBG random dimensions were observed being taken by ZPMC QC and appears to meet dimensional requirements of drawing RS9. Caltrans QA Inspector observed these same T-Beams being tack welded to Bottom plate using the FCAW process. Random visual and dimensional observations were performed and WT Stiffeners appear to meet requirements of drawings. However there are areas of discontinuities approximately, 40mm in length, observed by QA inspector where T-Beams were hand flame cut in order to split W21 see photo. Maximum depth of discontinuity did not exceed 6mm. ZPMC CWI Xu Xian ping stated areas of discontinuities over 3mm in depth will be removed as per D1.5 Table 3.1 page 51.
